TWR-17371

Space Shuttle Development Motor No. 9 (DM-9) Final Test Report

September 1990

Thiokol CORPORATION
SPACE OPERATIONS

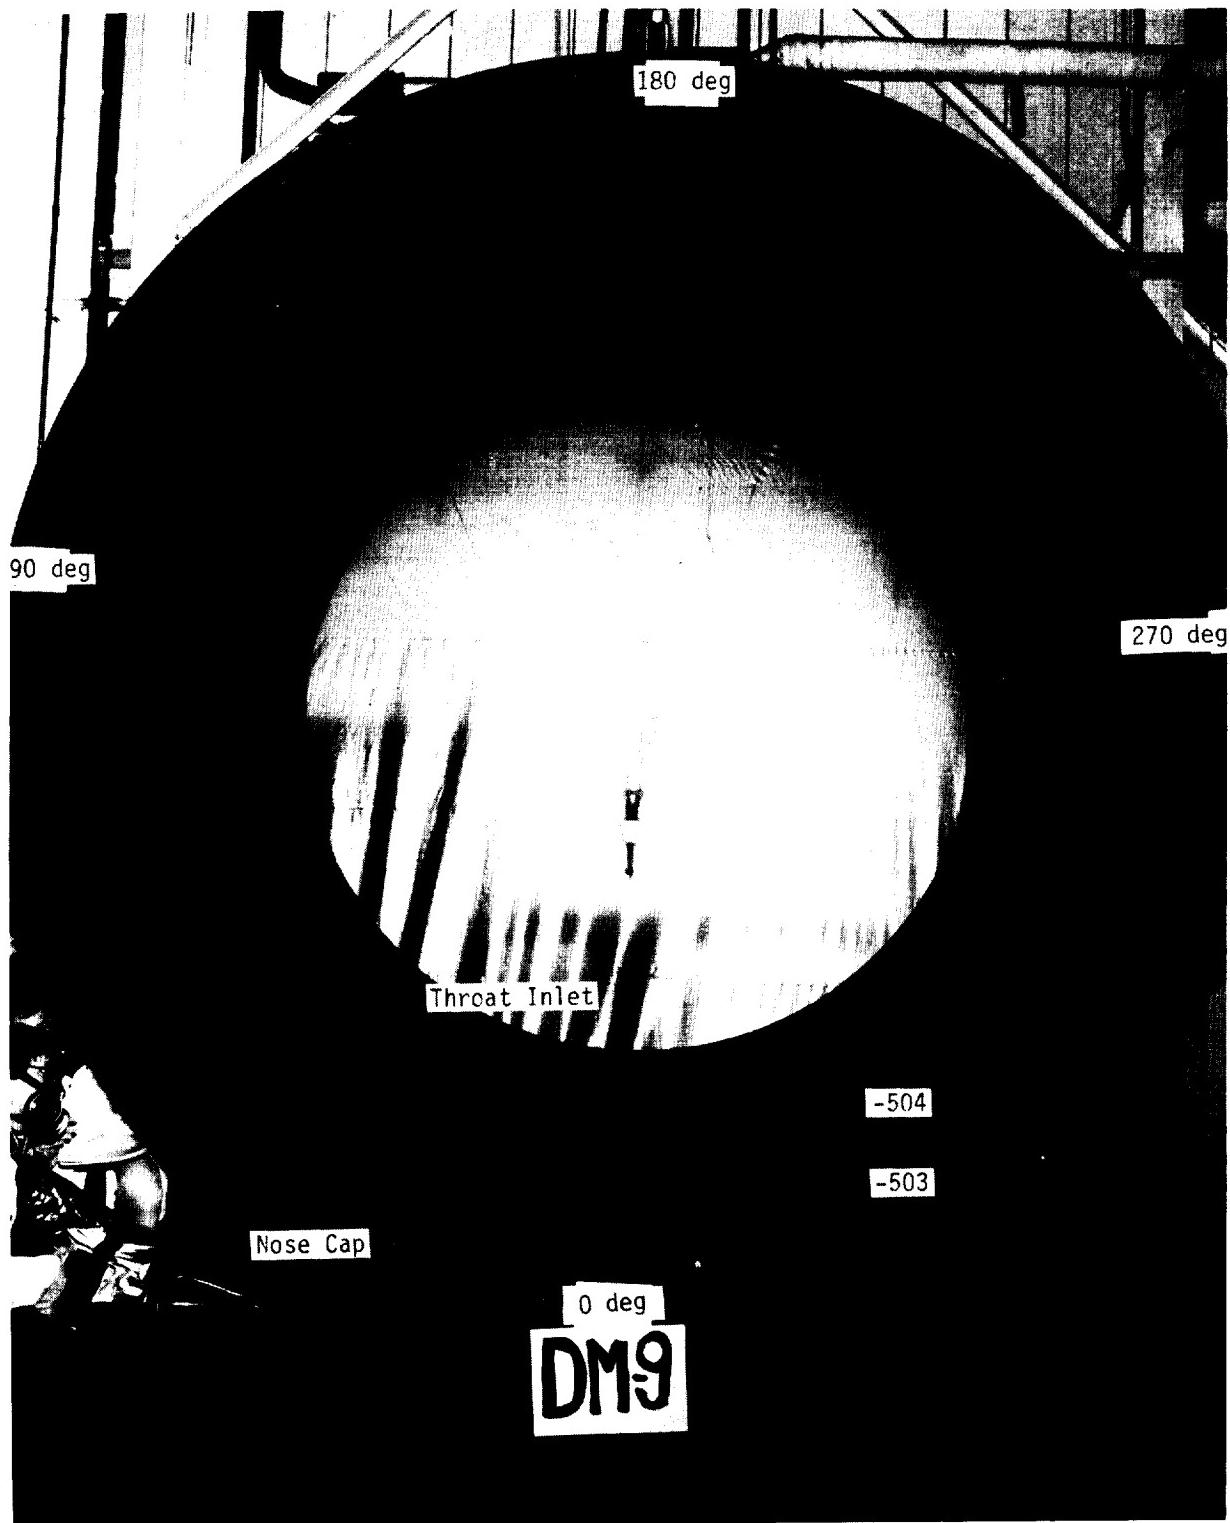
Figure 7.5-13. DM-9 Nozzle Overall Internal View

7.5.4.1 Nozzle Assembly. Erosion of the DM-9 forward nozzle assembly and aft exit cone CCP ablative liner was smooth and uniform. The involute OBR was fractured and missing from the nozzle over a 150-deg arc. Overall external and internal views of the DM-9 nozzle are presented in Figures 7.5-9 through 7.5-16.

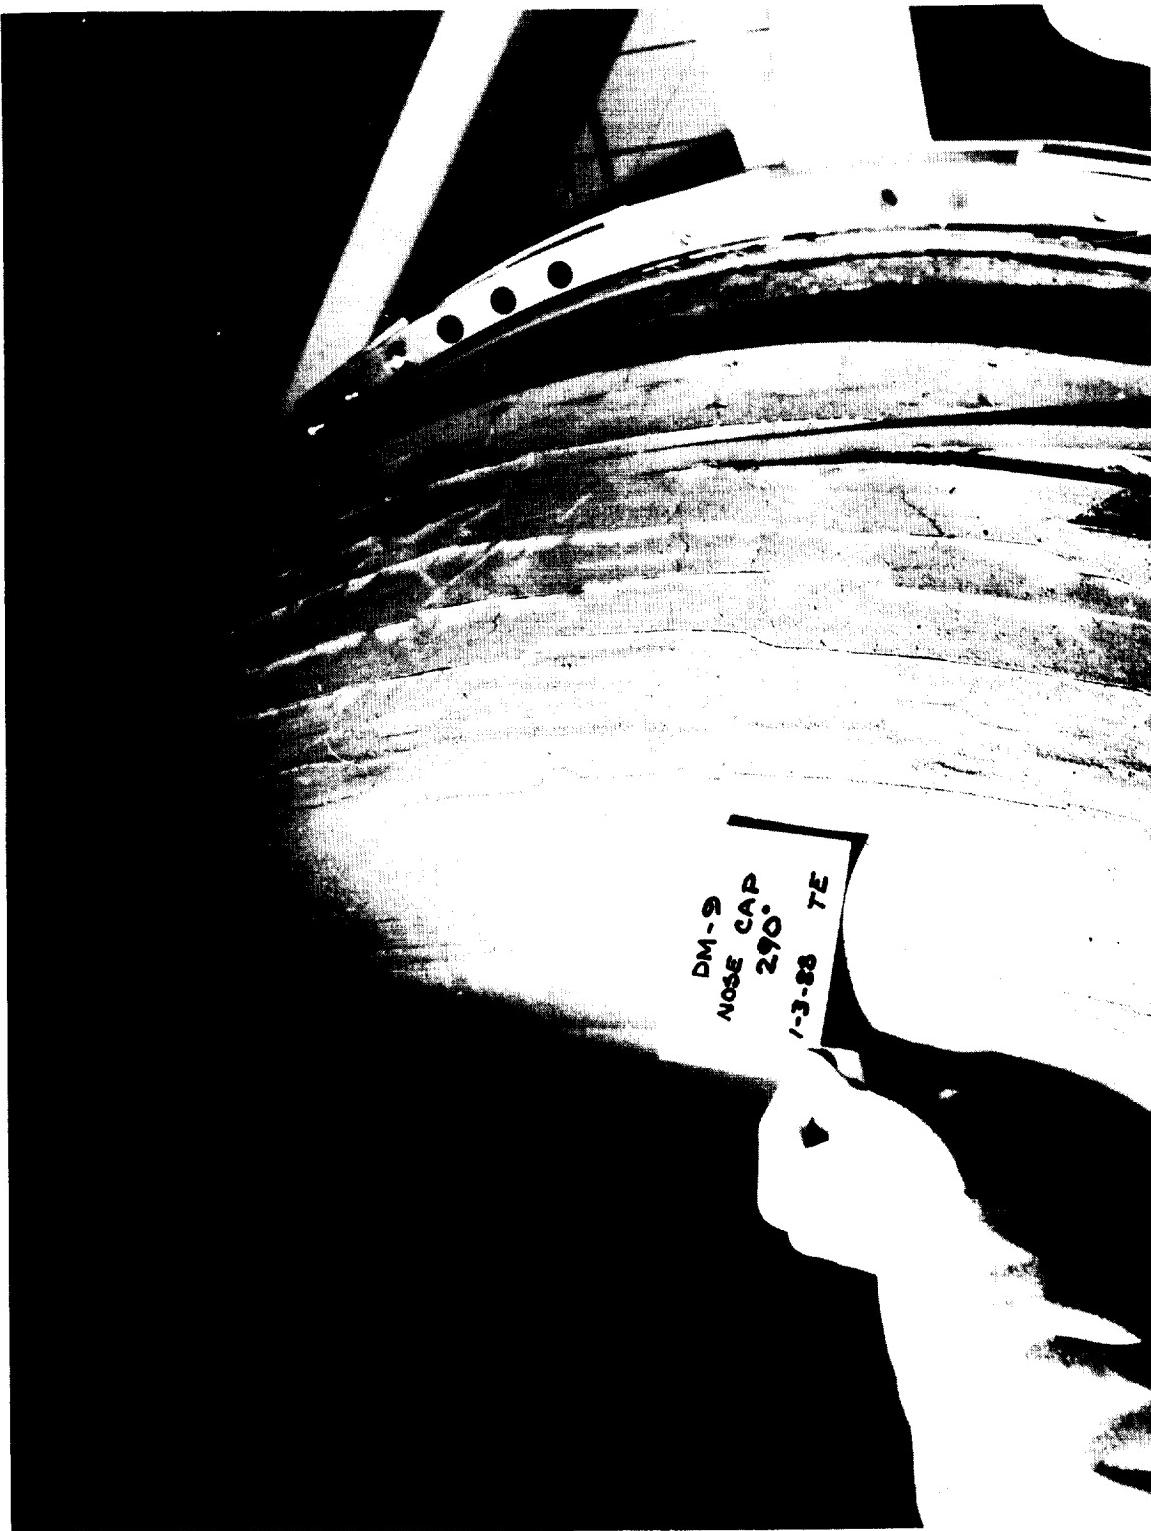
Figure 7.5-19. DM-9 Nose Cap Flow Surface (290 deg)

Charred CCP plies wedged out on the nose cap aft end intermittently around the nozzle circumference. Figures 7.5-9 through 7.5-12 and 7.5-19 show views of the wedged out areas. The poppedup and missing material occurred over the aft 2 to 2.5 in. of the nose cap and was a maximum of 0.5 in. deep radially at the cowl interface. Plies exposed after the material wedged out showed signs of heat effect,

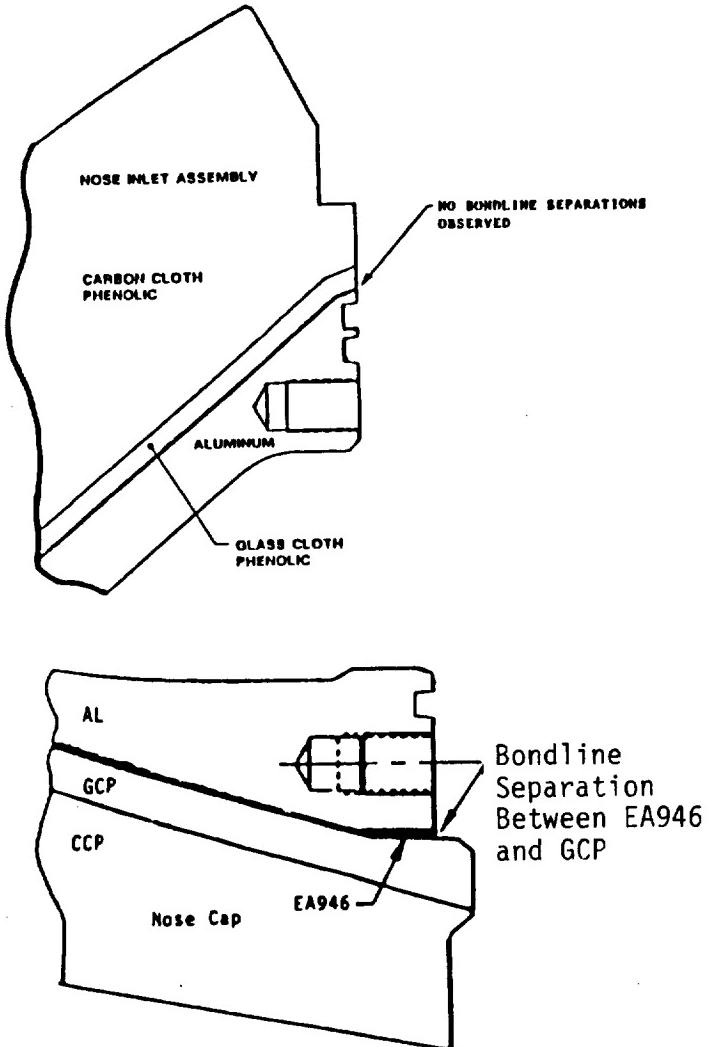
The nose cap aft end housing bondline exhibited a thin separation between the EA 946 adhesive and glass-cloth phenolic (GCP) insulator around the entire circumference. The separation was a maximum of 0.009 in. wide radially and 2.0 in. deep axially. Radial and axial gap measurements are presented in Figure 7.5-20. These separations were similar to those observed on the ETM-1A and DM-8 nose caps. No separations appeared between the EA 946 adhesive and nose inlet housing. There were also no cohesive separations observed within the adhesive at this bondline. It should be noted that the DM-9 nose inlet housing used the EA 9228 primer and PAA system.

Aft End Adhesive to GCP Radial Separation (in.)	Location (deg)
0.007	0
0.006	15
0.005	30
0.005	45
0.008	60
0.006	75
0.005	90
0.008	105
0.007	120
0.008	135
0.003	150
0.005	165
0.005	180
0.006	195
0.006	210
0.007	225
0.008	240
0.009	255
0.007	270
0.005	285
0.005	300
0.007	315
0.006	330
0.008	345

Figure 7.5-20. DM-9 Nose Inlet Assembly Bondline Separation

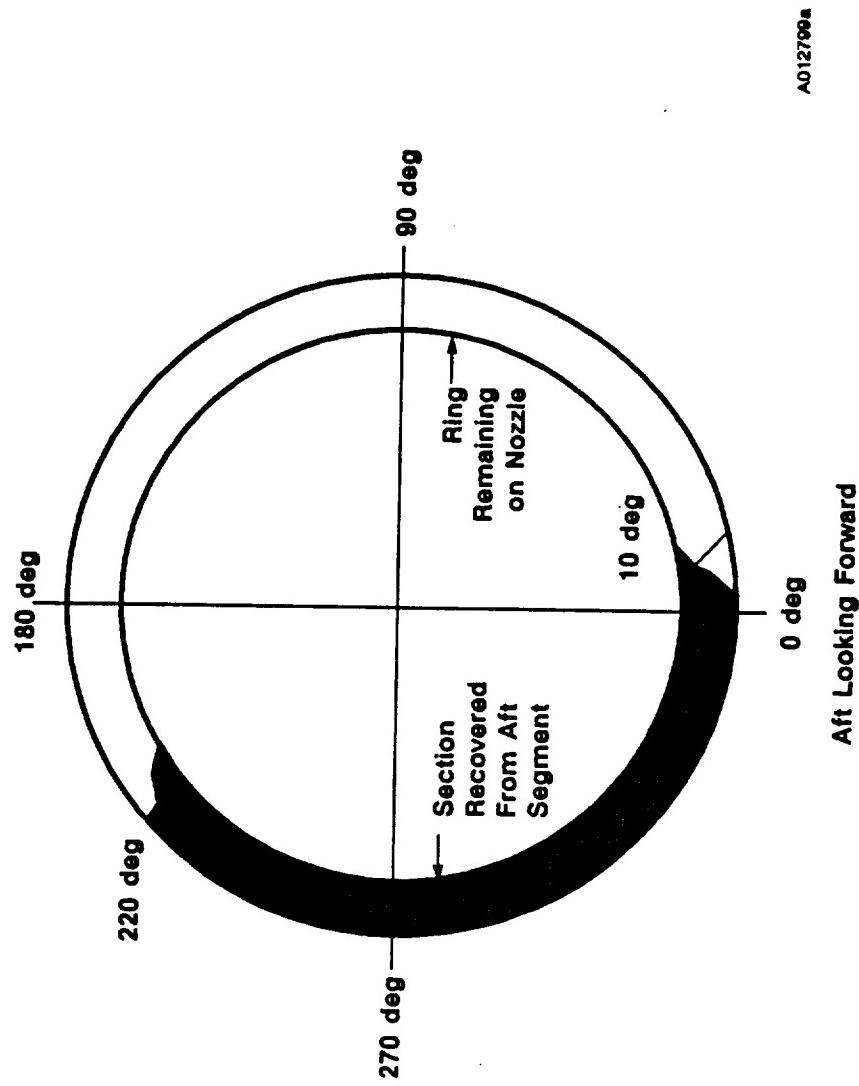
Figure 7.5-21. DM-9 OBR Post-Test Condition

The outer boot ring separated from the nozzle over a 150-deg arc from 220 to 10 deg

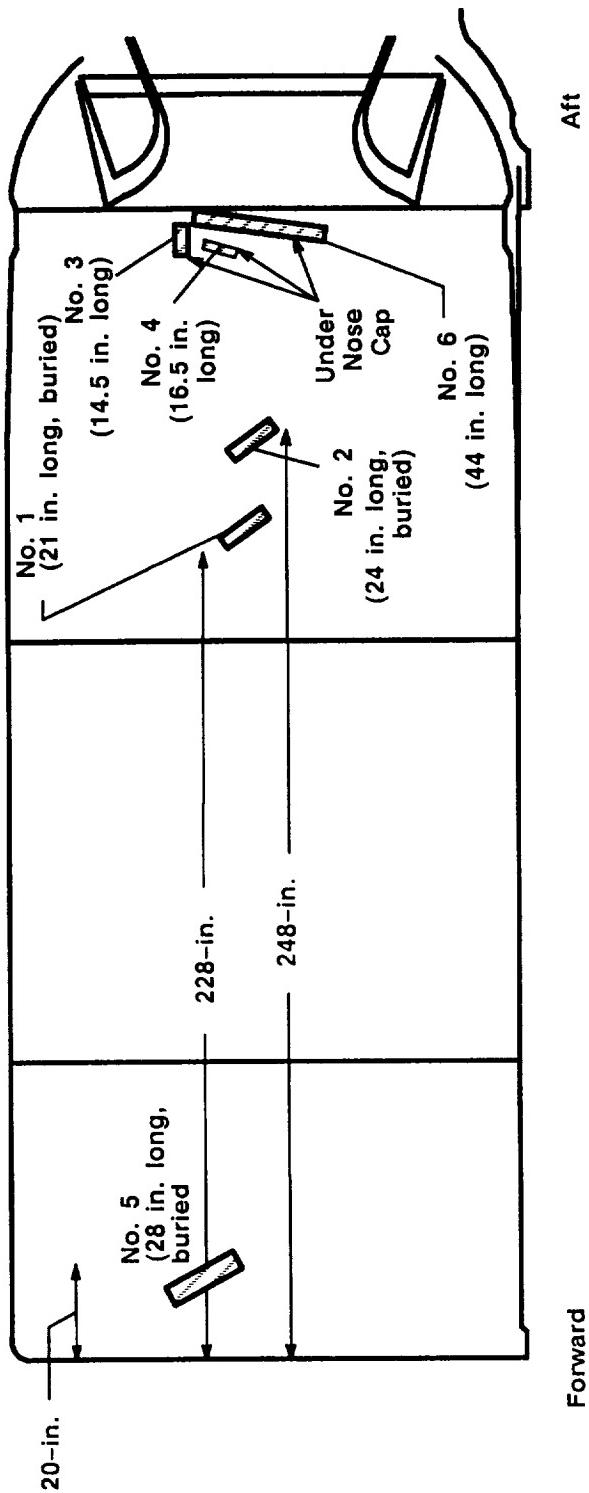
The DM-9 involute OBR separated from the nozzle over a 150-deg arc from 220 to 10 deg (Figure 7.5-21, TWR-17916). Six pieces of the OBR were found on the floor of the aft segment (Figure 7.5-22). Three pieces were observed on the slag surface during initial inspection, and three were later found buried in the slag. The six broken-off pieces made up the majority of the missing OBR. A small portion of char cap located at approximately 10 deg was not recovered. Overall photographs of the nozzle showing the missing OBR are shown in Figures 7.5-9 and 7.5-12.

Figure 7.5-22. Locations of Six Recovered Pieces From DM-9 Aft Segment

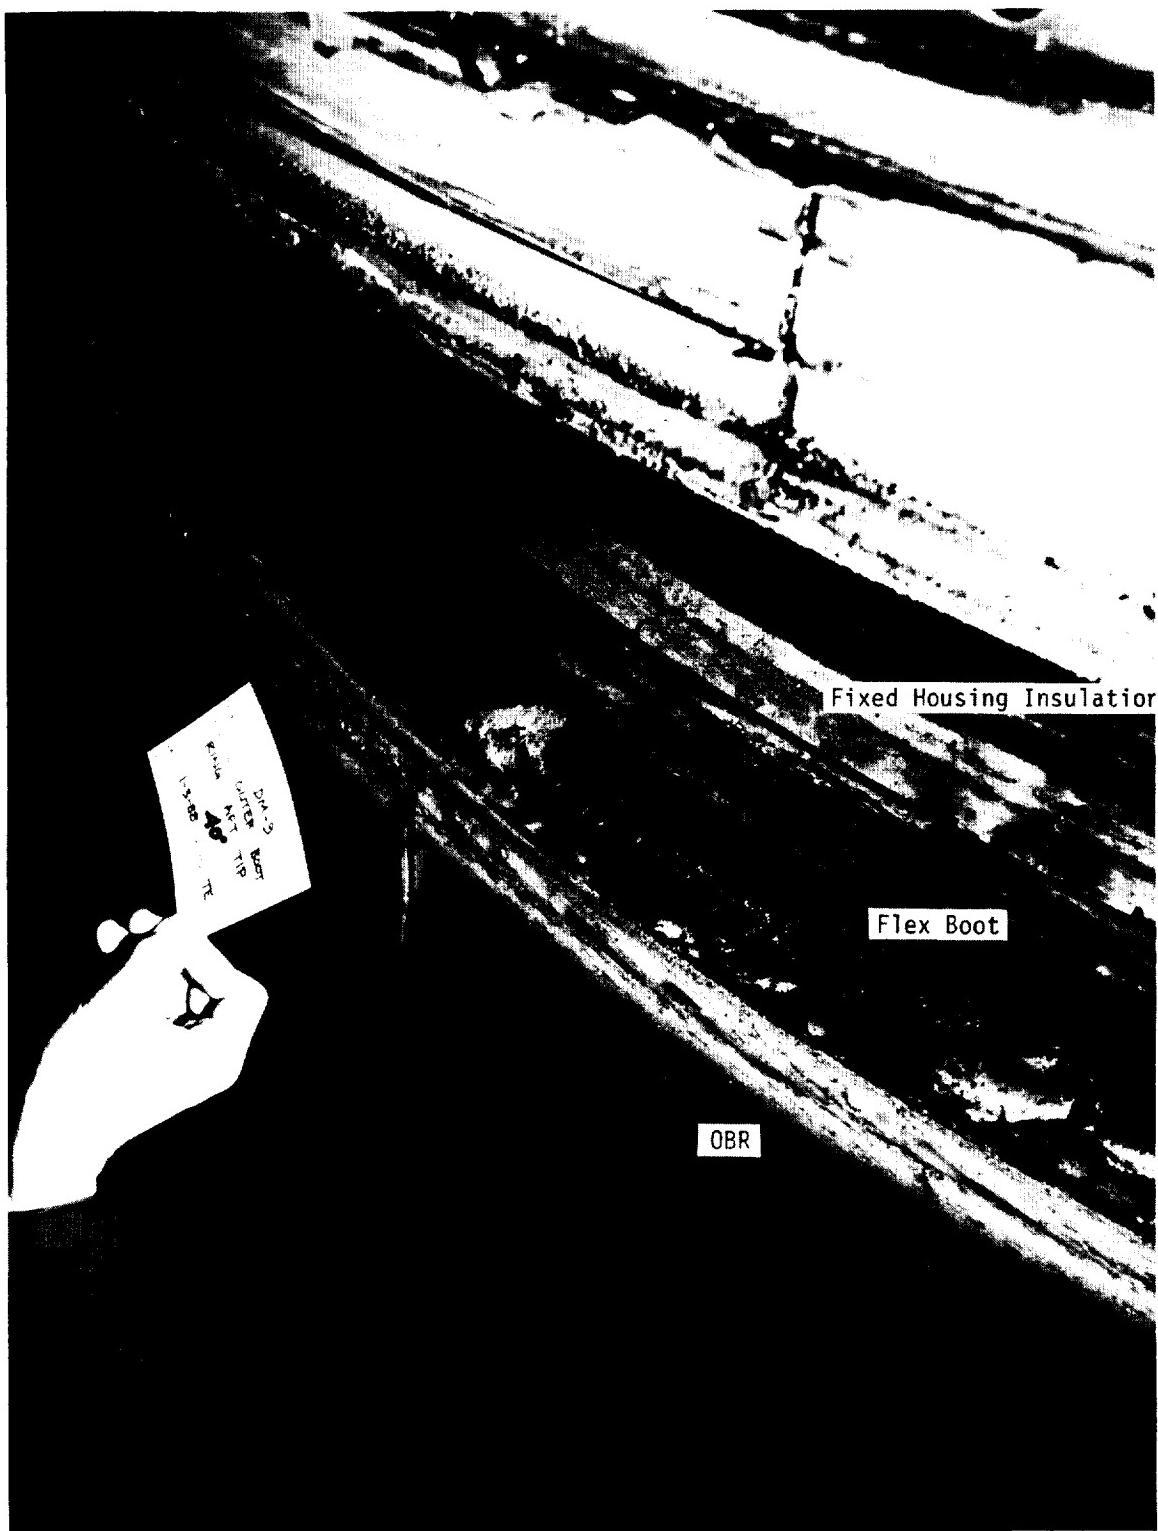
The involute OBR remained intact and bonded to the nozzle from 10 to 220 deg (Figures 7.5-23 through 7.5-25). The intact portion showed cooldown cracks and delaminations that extended along the involute ply. Figure 7.5-26 presents a map of the cracks and delaminations. There were no through delaminations (OD to ID) that extended through virgin CCP material. Two through delaminations isolated in charred CCP were observed from 20 to 40 deg and 110 to 145 deg; these were aligned with ply-lift regions. Sectioning of the OBR showed delaminations extending into virgin CCP material at 40, 80, 120, and 140 deg (Figures 7.5-27 and 7.5-28). These delaminations propagated from the aft end of the OBR and showed no signs of heat effect in the virgin material during cooldown.

Figure 7.5-23. DM-9 Intact Portion of OBR (40 deg)

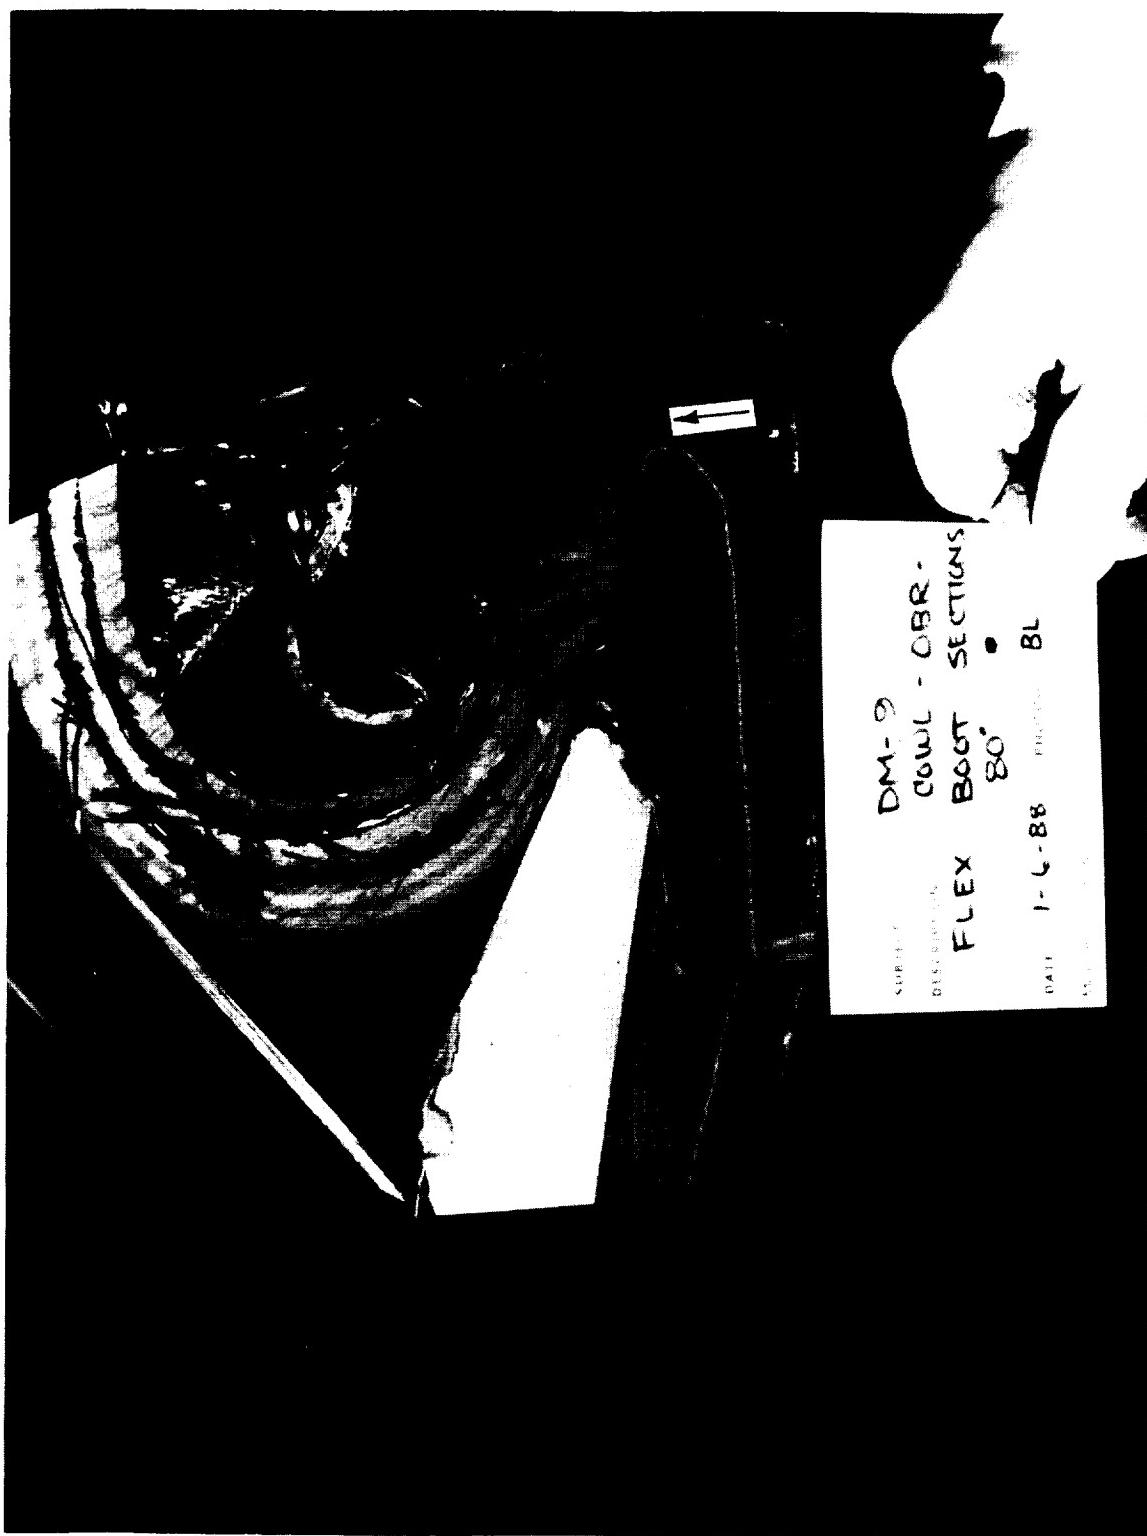
Figure 7.5-28. DM-9 Detam Extending Into Virgin CCP Material on OBR (80 deg)

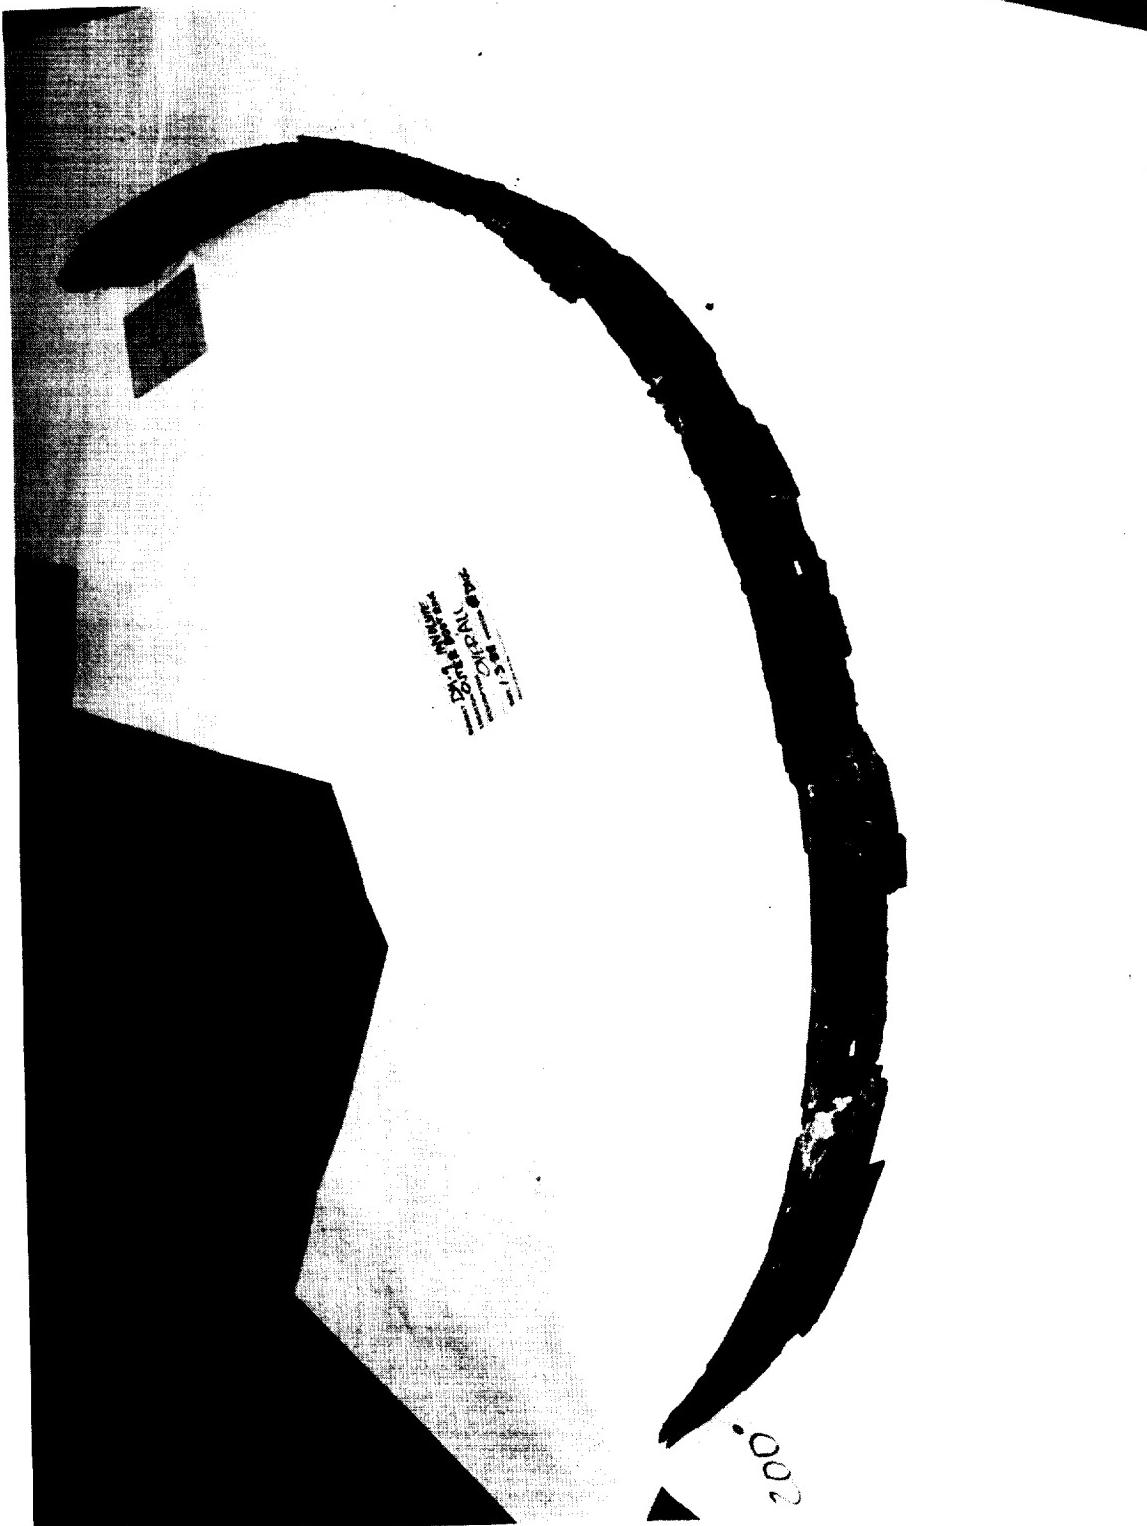
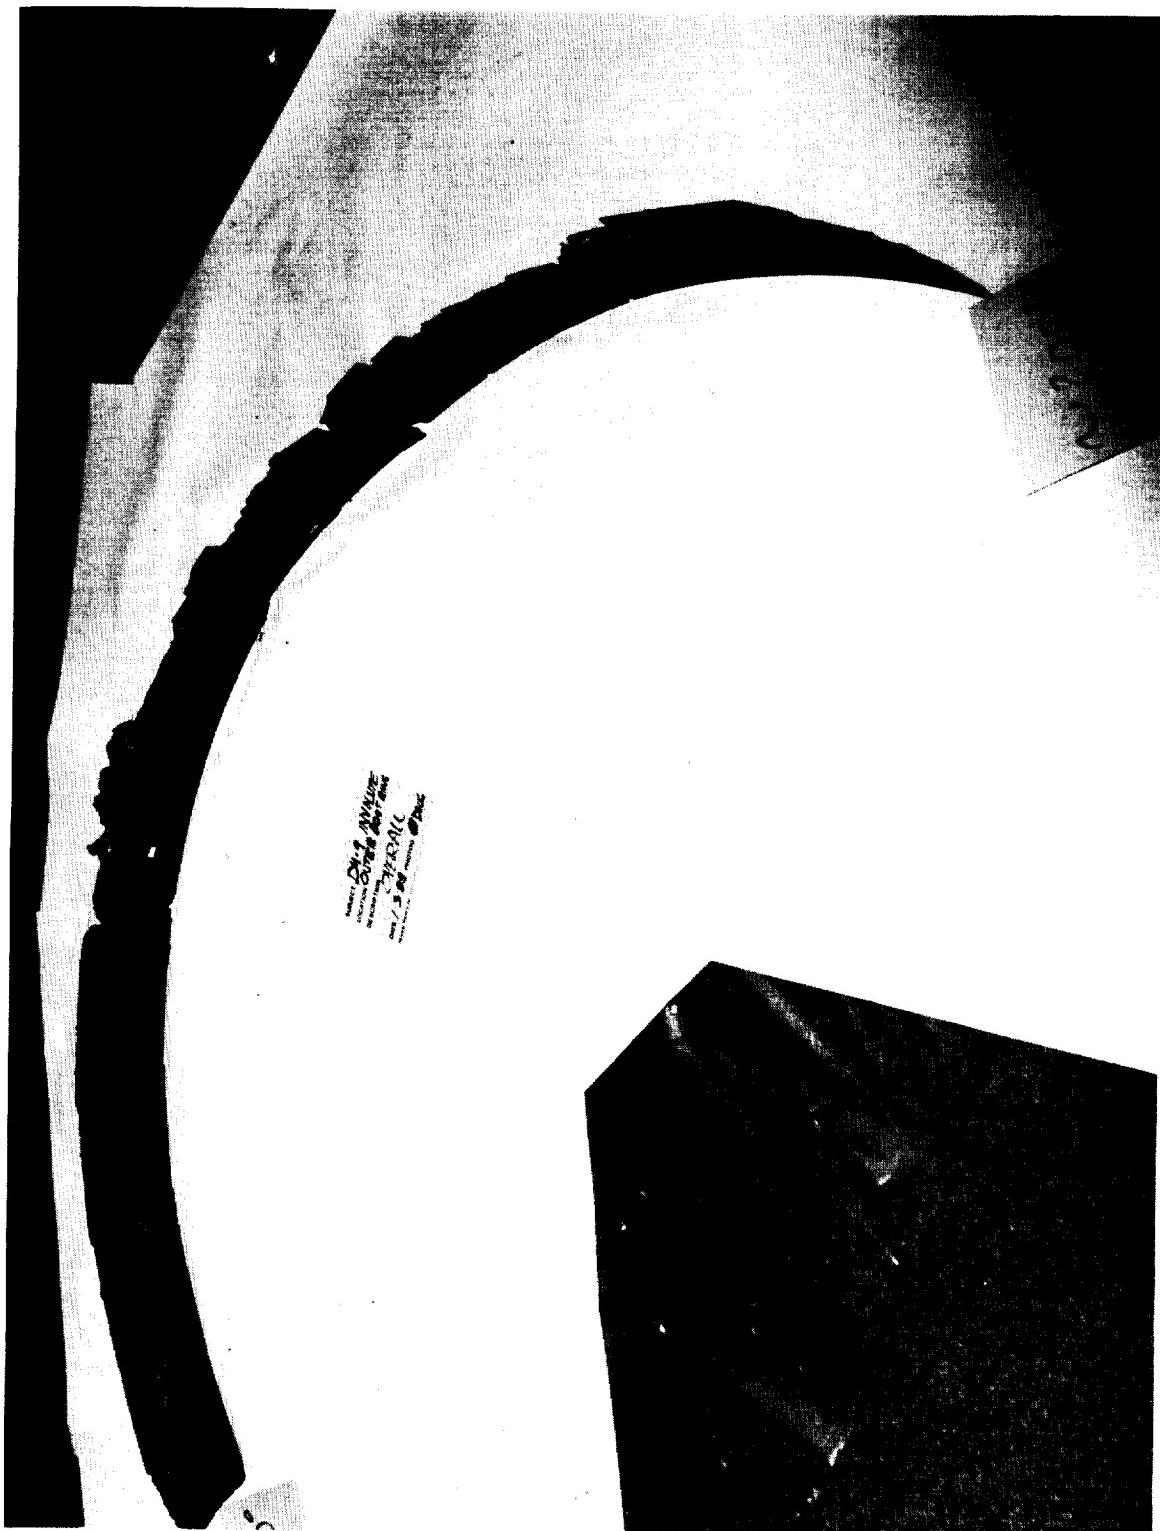
The six pieces of the OBR found on the floor of the aft segment were reassembled and examined (Figures 7.5-31 through 39). Figure 7.5-40 is a map of the reassembled pieces. Figure 7.5-41 describes the fracture edges and overall condition of Piece No. 1. Piece No. 2 is summarized in Figure 7.5-42. Figures 7.5-43 through 7.5-46 describe Piece No. 3, and Figures 7.5-47 through 7.5-50 characterize Piece No. 4. Piece No. 5 is described in Figure 7.5-51, and Figures 7.5-52 and 7.5-53 summarize Piece No. 6.

Figure 7.5-31. DM-9 Reassambled Six Pieces of Inolute OBR

Figure 7.5-32. DM-9 Reassembled Six Pieces of Involute OBR

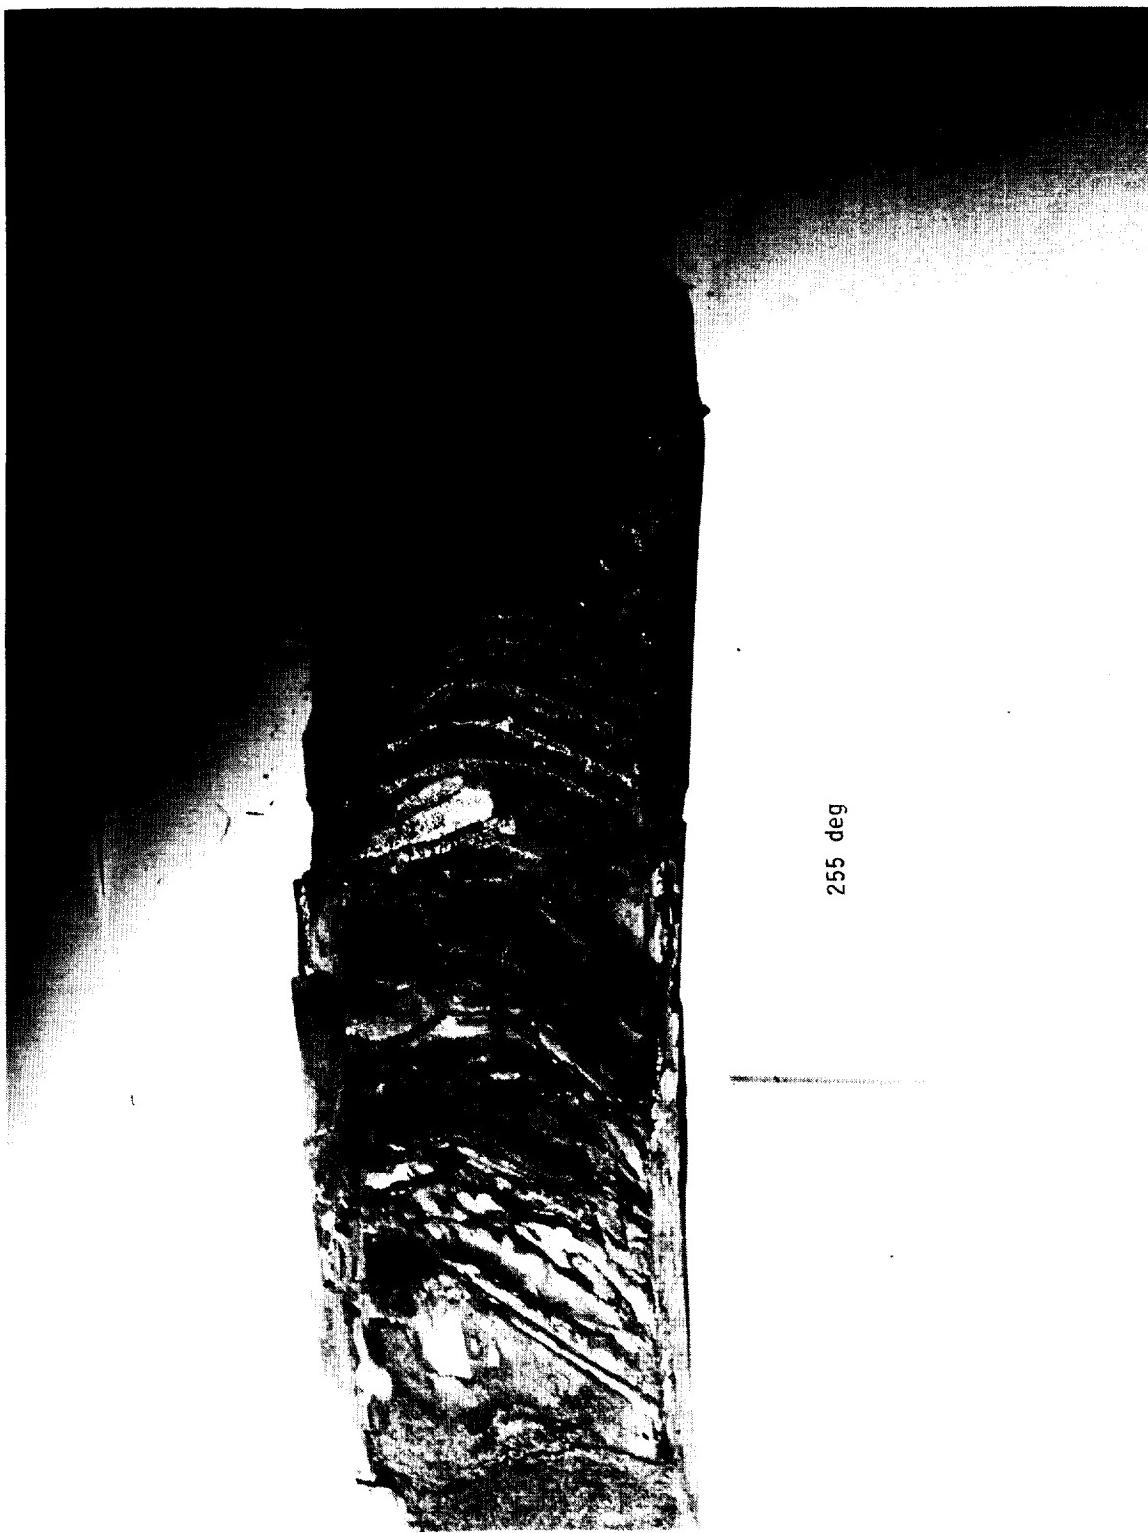
Figure 7.5-34. DM-9 OBR Piece No. 2 Recovered

- Piece No. 2—245 to 265 deg— was found buried in slag approximately 6.0 ft forward of the nozzle nose cap

- Sectioning revealed that Piece No. 2 was completely charred through
- The 245-deg and 265-deg fractured ends of Piece No. 2 showed signs of both cross-ply and with-ply failure
- The 245-deg and 265-deg fractured ends contained indications of bending fracture
- Erosion was not present on fractured or ID surfaces

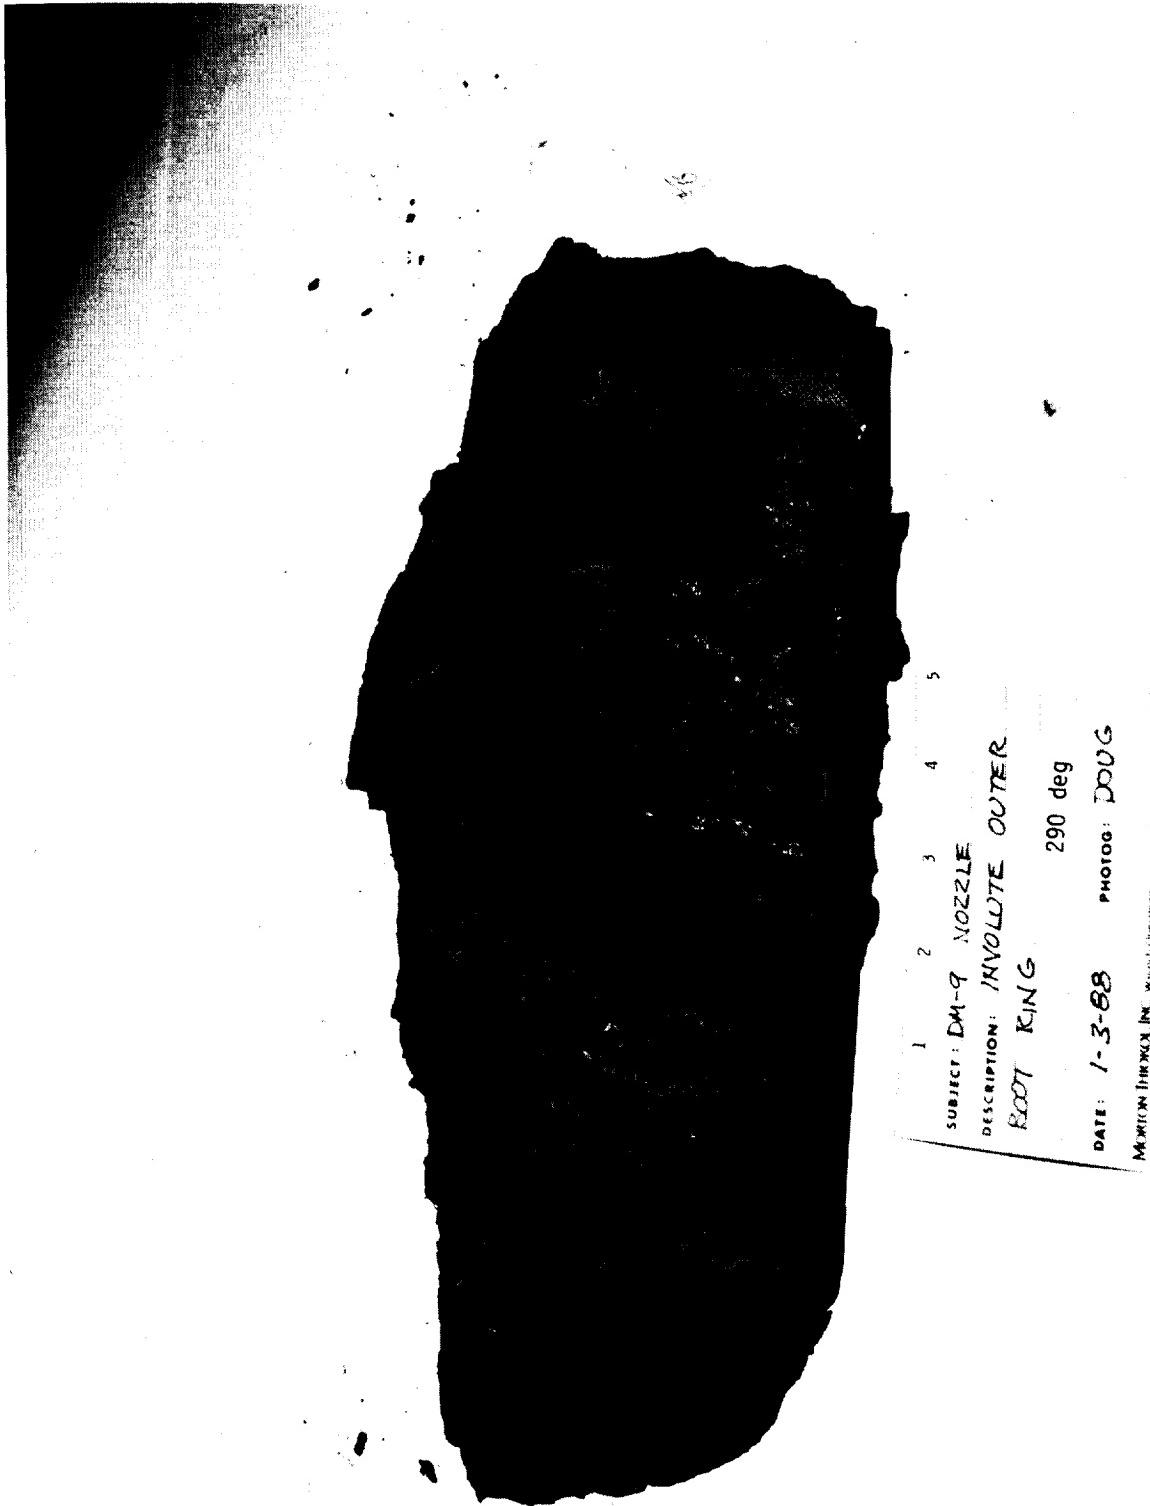
Figure 7.5-36. DM-9 OBR Piece No. 4 Recovered

- Piece No. 4—285 to 295 deg—was found under the nozzle nose cap lying on top of the slag
- Sectioning revealed that Piece No. 4 was completely charred through
- The 285-deg and 295-deg fractured ends of Piece No. 4 failed with-ply, with localized cross-ply fracture
- The 285-deg and 295-deg fractured ends contained indications of delamination with mechanical load assist
- Erosion and flow indications were found near the ID surface along through-delamination (photo micrographs show rounding of the fibers—Figure 7.5-50)

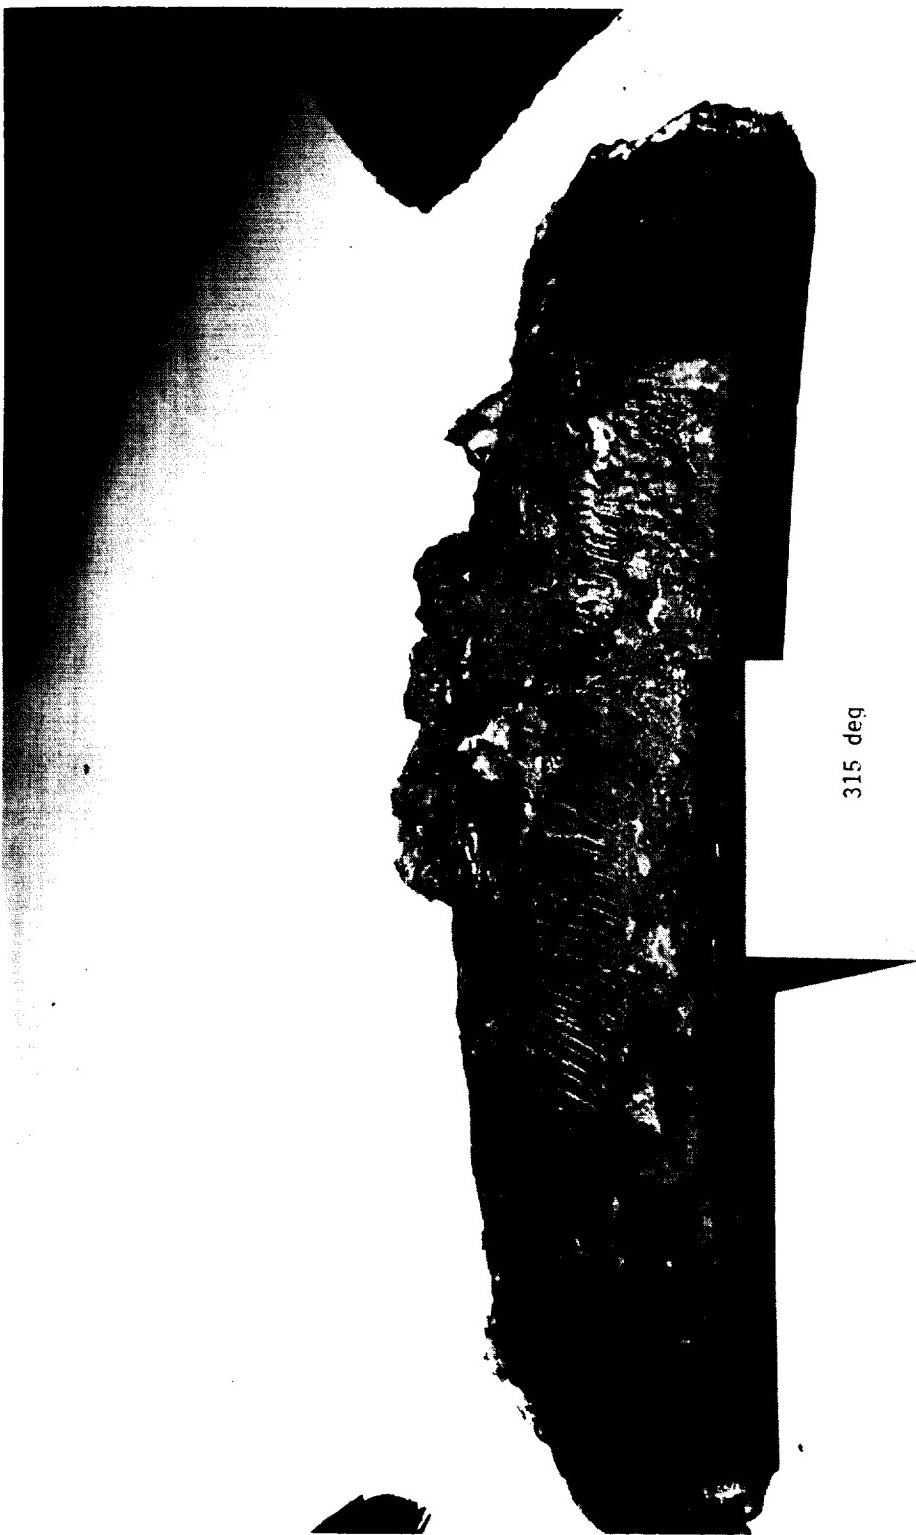
Figure 7.5-37. DM-9 OBR Piece No. 5 Recovered

- Piece No. 5—295 to 325 deg—was found buried in the slag 27 ft forward of the nozzle nose cap
 - Sectioning revealed that Piece No. 5 was completely charred through
 - The 295-deg fractured end of Piece No. 5 was with-ply, with localized cross-ply fracture
 - The 295-deg fractured end contained indications of delamination with mechanical load assist
 - The 325-deg fractured end of Piece No. 5 showed a complete radial (cross-ply) failure
 - The 325-deg fractured end contained indications consistent with hoop tension or bending fracture
 - Erosion was not present on fractured or ID surface
-

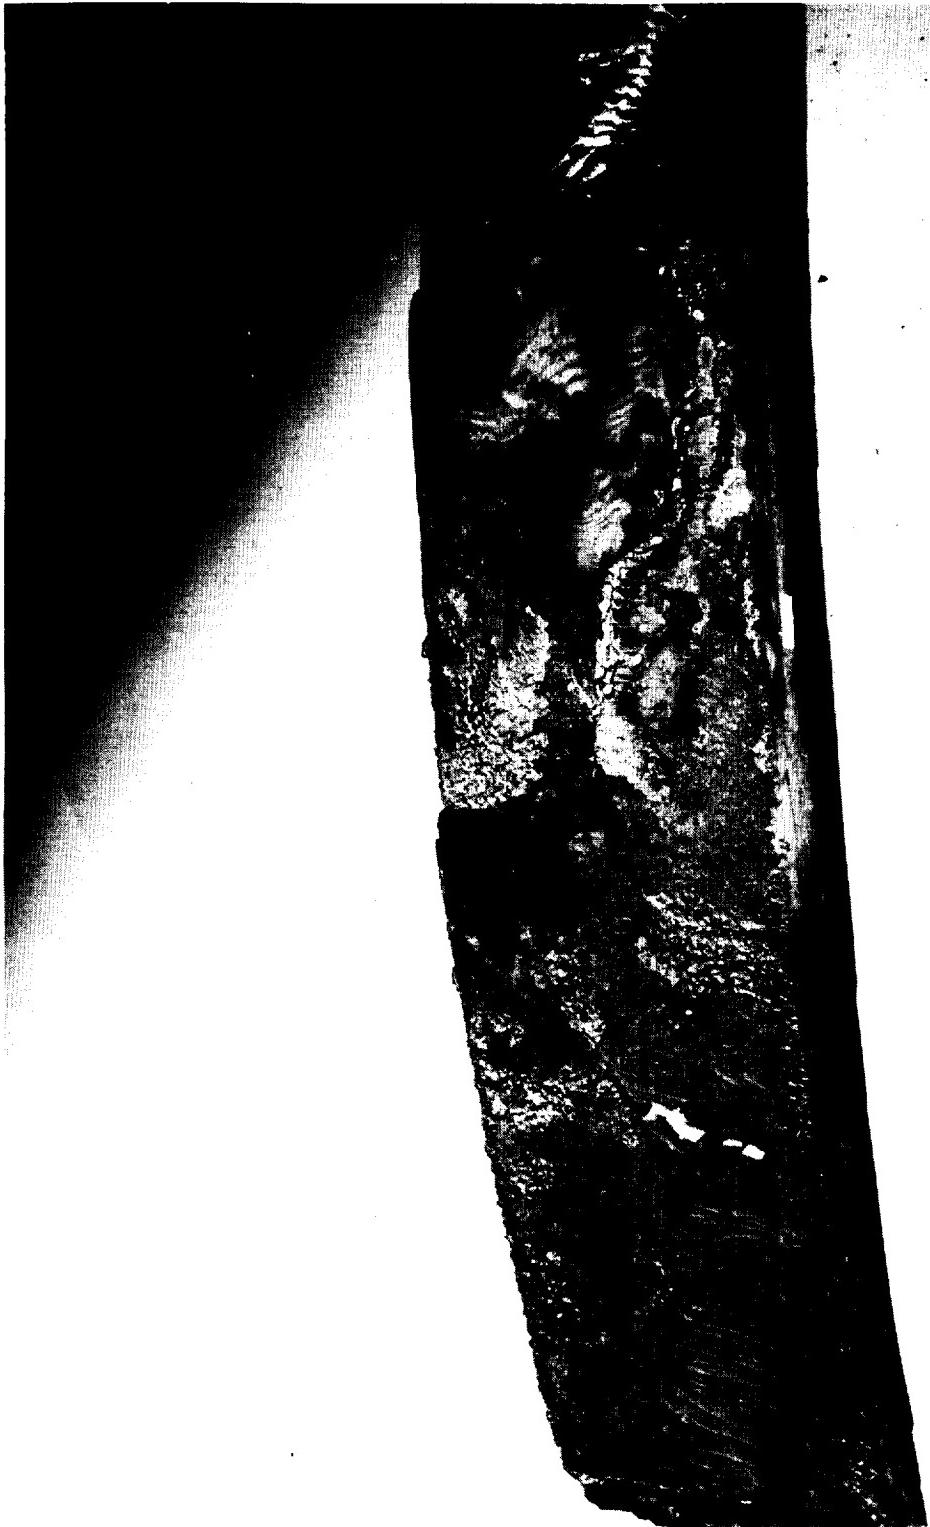
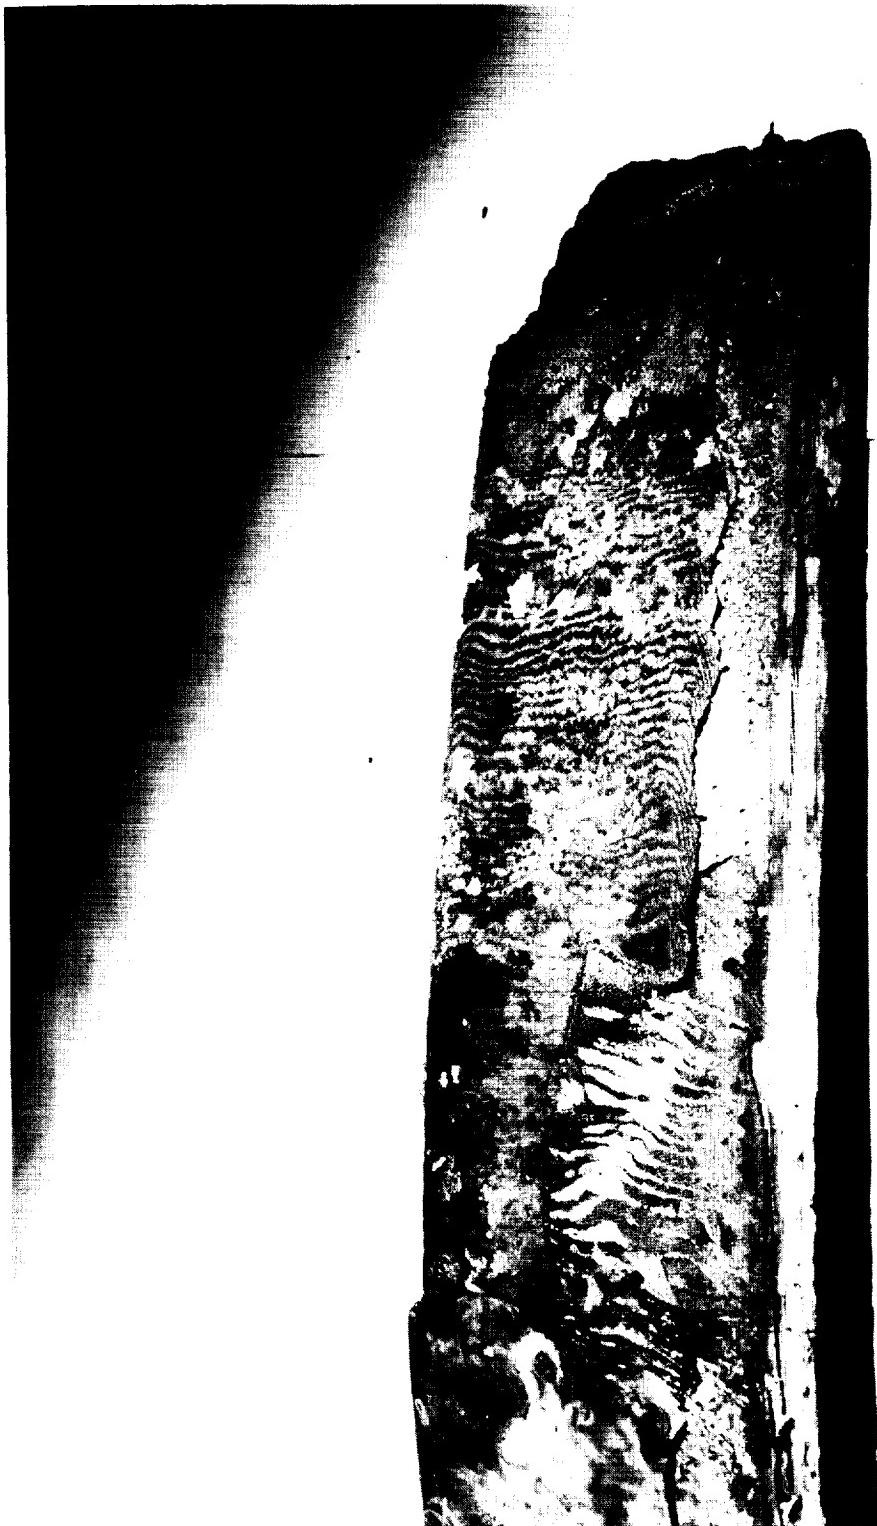
Figure 7.5-38. DM-9 OBR Piece No. 6 Recovered

Figure 7.5-39. DM-9 OBR Piece No. 6 Recovered

- Piece No. 6—325 to 10 deg—was found under the nozzle nose cap, lying on top of the slag
